WEST THOMPSON DAM & RESERVOIR

QUINEBAUG RIVER, CONNECTICUT

DESIGN MEMORANDUM NO. 2

SITE GEOLOGY

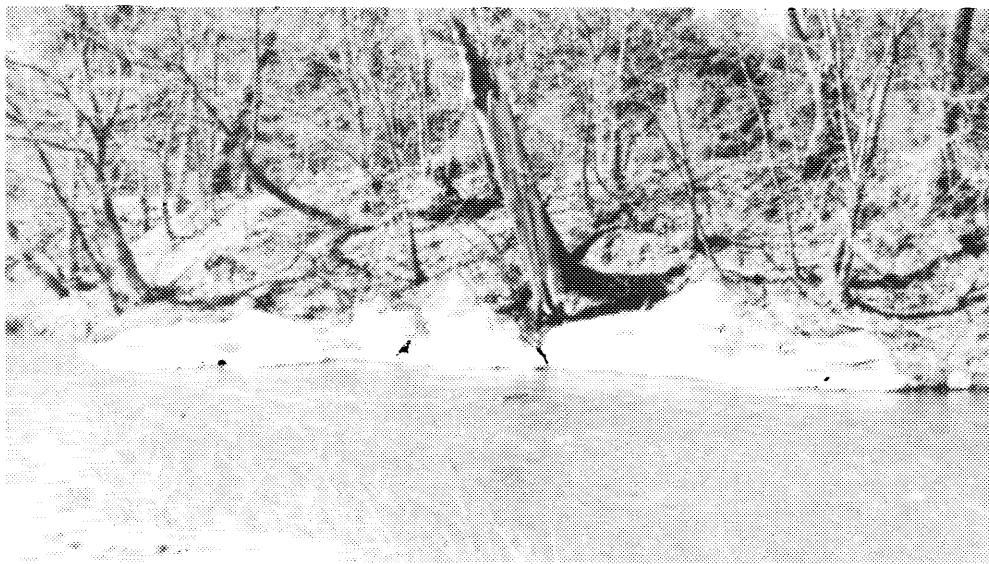
OUTCROP (GNEISS) AT OUTLET WORKS INTAKE

Figure 1. Outcrop (Gneiss) at Outlet Works Intake and
Boulders on Spillway Centerline

the area upstream of the centerline of the dam. (See Figure 1) This distribution in the spillway area is consistent with a sand stratum which, coupled with the general conformity of the bedrock surface, indicates a glacial spillway at approximately elevation 340. (See Plate 2-4) The sandy till which overlies the bedrock surface in thin pockets throughout the right abutment is apparently remnants of a former general distribution removed by discharging melt waters which have deposited sands and gravels over the bedrock surface. (See Plate 2-5) Deposition in the valley is in excess of 60 feet and consists of sandy till lying in thin pockets over the bedrock surface, blanketed by thick glacial lake deposits of stratified silts and sands which locally vary to highly micaceous zones and to zones of coarse sands. The surface of a continuous deposit of coarse sandy gravel forms the valley floor and varies from 10 to 20 feet in thickness. Buried, per-vious-filled old stream channels may possibly exist within the valley section but their presence has not been revealed or indicated by the explorations. The overburden of the left abutment is comprised of till, outwash and terrace remnant materials con-taining cobbles and boulders, averaging 15 to 20 feet in thickness and thinning at higher elevations. The general stratigraphic se-quence of the overburden in the dam foundation is shown on Plate 2-5.

12. Bedrock as exposed in the right abutment area varies from a gneissic to massive granitic rock in the outlet approach channel (See Figure 1) along the river bank to a biotite schist highly metamorphosed and granitized in the vicinity of the spillway structures. Borings reveal the rock to be generally a granitized schist with zones of extensive granitization where the rock varies from a gneiss to granite. A slight to highly weathered and jointed condition prevails in the bedrock to a depth of 5 to 10 feet below the rock surface. (See Plates 2-5 and 2-6) In some areas, such as the northeast corner of the spillway weir and approach channel, the depth of weathering and jointing increases to approximately 15 feet. The trend of structural foliation nearly parallels the spillway structures and is generally N 50° to 60°W with a foliation dip at the surface of 30° to 55° to the west and generally becoming steeper with increasing depths. Random jointing occurs throughout the borings with the most persistent jointing being a steeply dipping strike to diagonal joint system. (See Page 2-3)

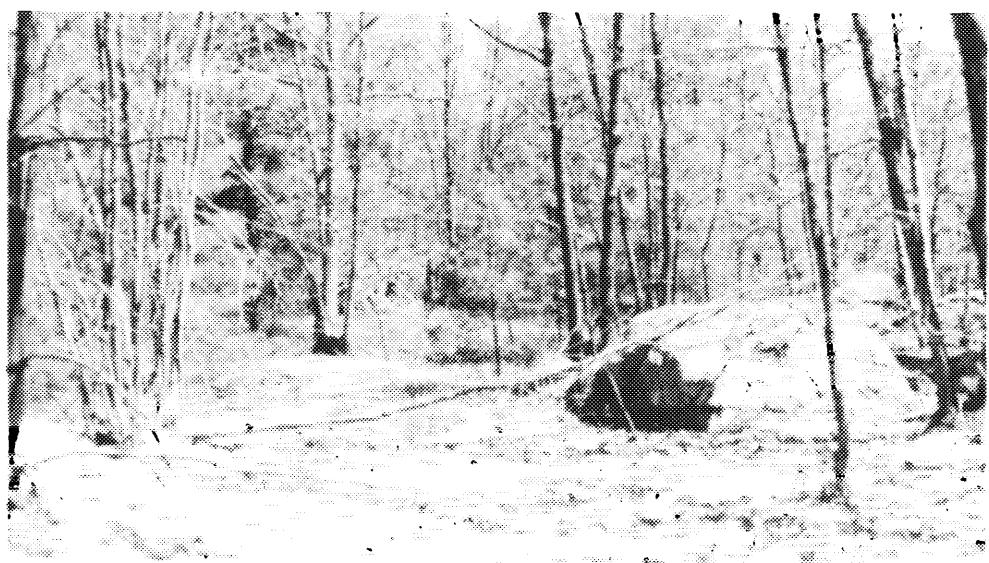
BOULDERS ON SPILLWAY CENTERLINE
